The performance of low-rise open span heavy steel structures in extreme winds

The Performance of Low-Rise Open Span Heavy Steel Structures In Extreme Winds

Joe R. Charlton, B.S., P.E.

A REPORT

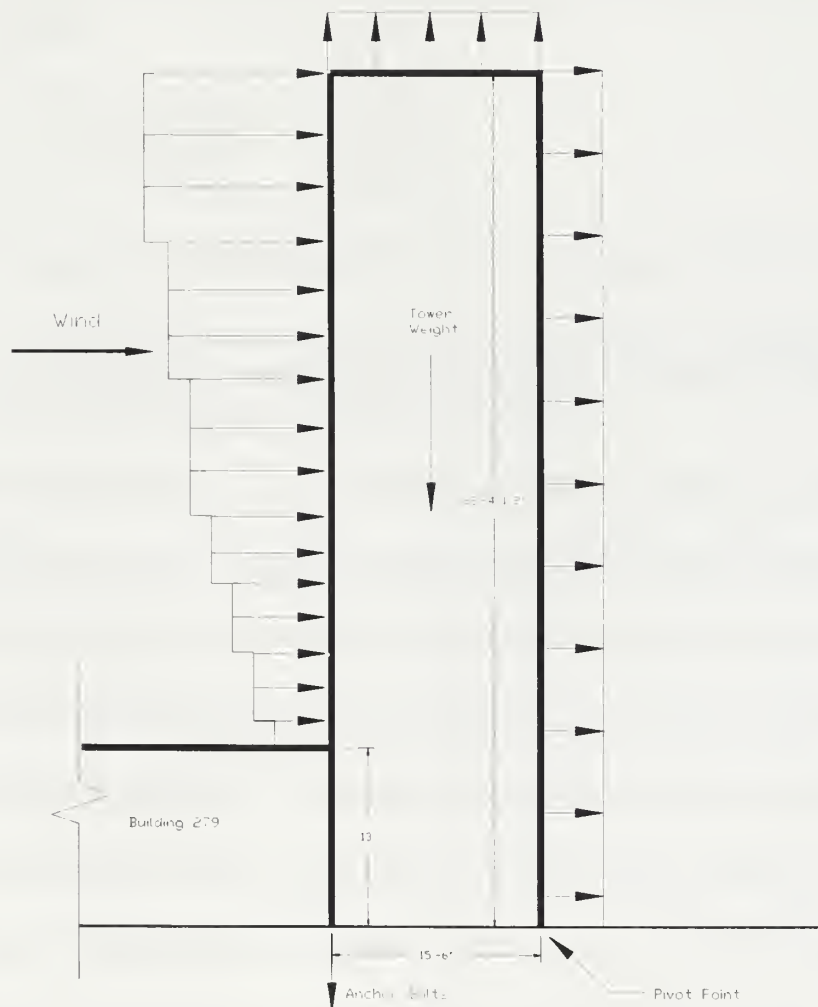
Figure 4.11 Forces Acting on Parachute Tower

The wind that caused the collapse of the parachute tower was generated by the Altus, Oklahoma tornado that was described earlier in Section 3.5. The wind caused the collapse of the parachute tower by generating enough force to cause failure of the column anchor bolts and also overcome the righting moment generated by the weight of the building. An illustration of the forces acting on the structure can be seen in Figure 4.11, below.

Using this approach, the overturning moment, M_o , was found to be 45.9q ft*kips, where q is the wind pressure on the structure. Equating the righting moment, M_r , and the overturning moment, M_o , and solving for q , the wind pressure was determined to be approximately 48.0 psf. The minimum wind velocity to cause failure is then calculated using the equation, $V = \sqrt{q/.00256}$. Using this equation the minimum failure wind velocity was found to be 136 mph.

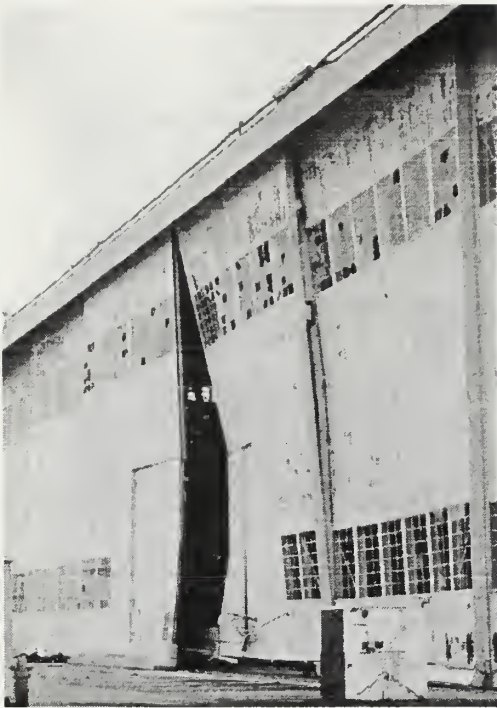
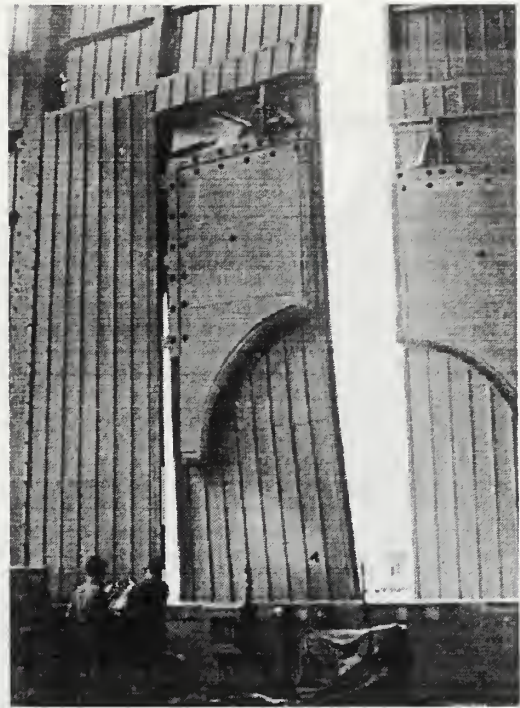
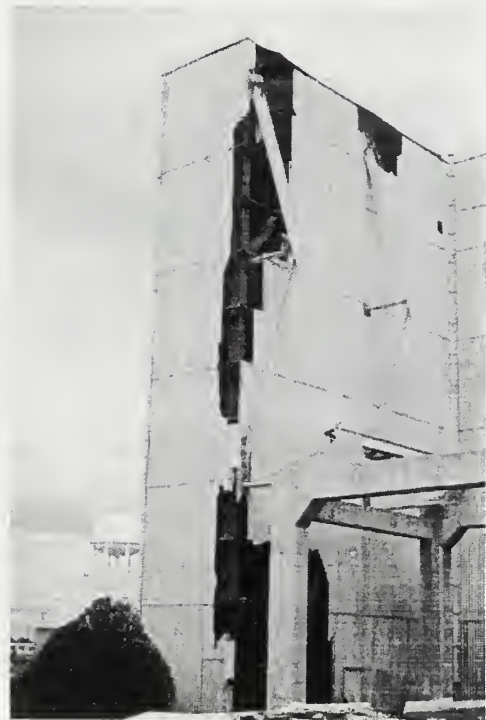
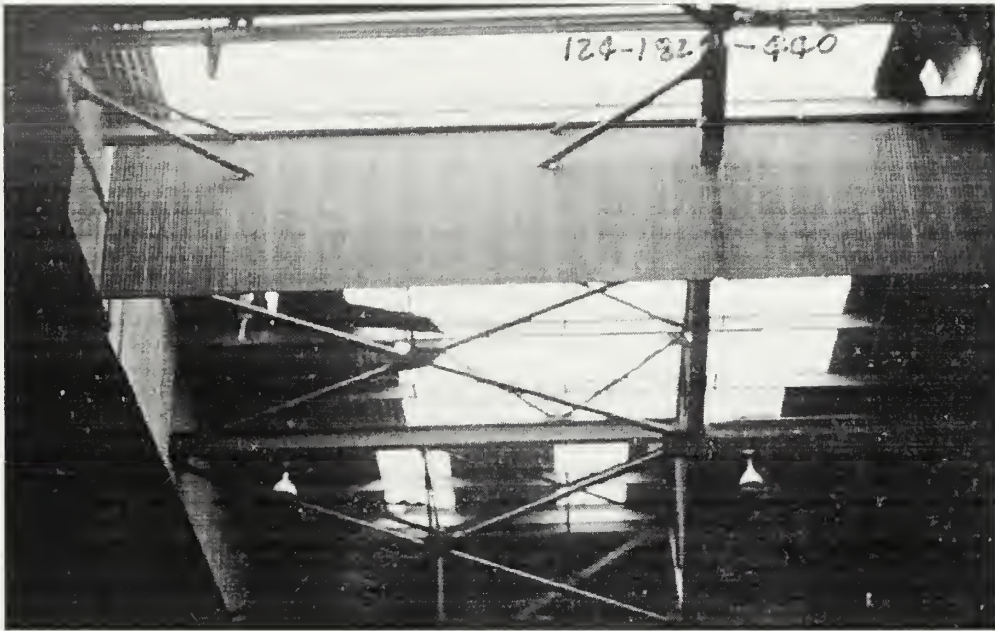
Overall, the hangar performed well when subjected to these severe winds. The exterior corrugated asbestos siding performed well and experienced only localized failure. There were no failures noted in the heavy “C” channel wall girts or the roof trusses supporting the corrugated siding and the roof decking, respectively. No failures were noted on the main structural elements. The only damage to this building was the removal of a portion of the roofing material and the roof decking, structural damage to two rail mounted hangar door sections, and the removal of exterior corrugated siding along the door pockets. The damage to the hangar is shown in Figures 4.12 through 4.17.

As previously mentioned, the elements of the structure that were damaged include two sections of the hangar doors, the corrugated siding, the roof covering, and the roof decking. Since this structure is located over 500 miles from the nearest coastline, the maximum design wind speed used by the designers was probably less than 100 mph. Since the wind speeds experienced by the structure were approximately 30 percent faster than the design wind speed, the resulting loads were over 50 percent larger than the design loads. Under these extreme wind loads, the small amount of damage as seen in the previous figures is expected. However, an analysis of the damage is still useful to determine the weak points in the structure and identify areas where improvements can easily be made.

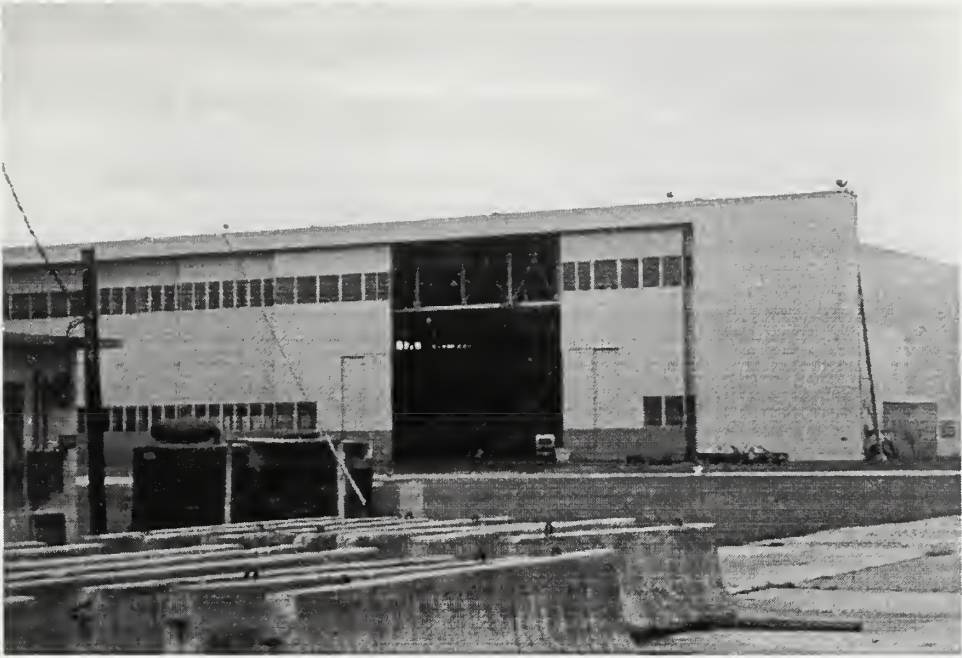
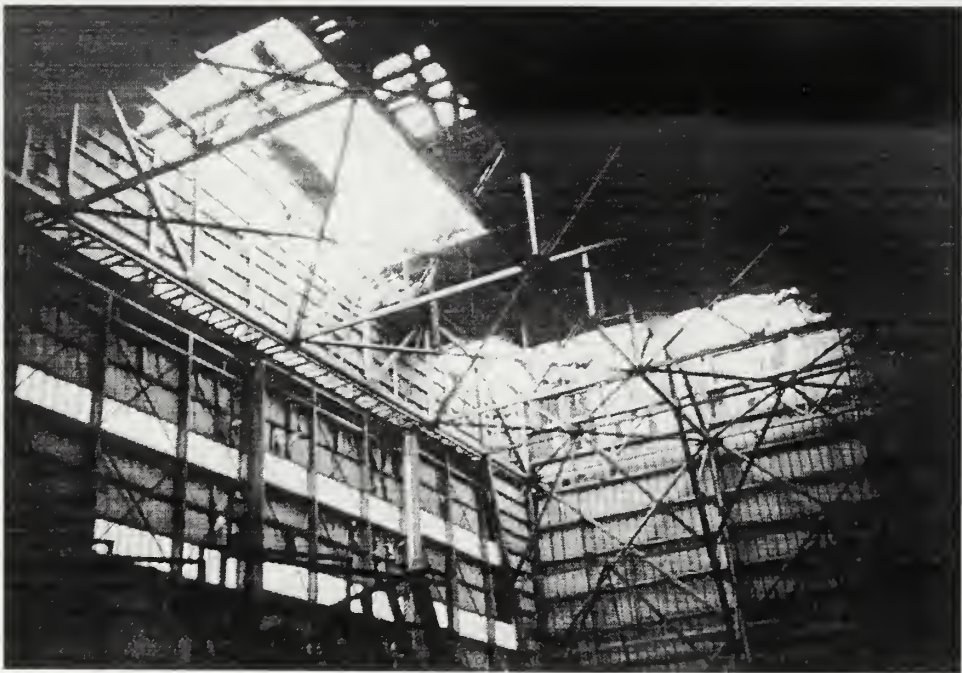
The only visible damage to this hangar is damage to the roof covering and decking. All of the structural members performed as designed, as did the corrugated metal siding. All of the windows in the structure remained intact, as did the hangar doors. These observations of the extent of the damage generally agree with the assessment by McDonald and Smith, 1990. The extent of the damage can be seen in Figures 4.22 and 4.23.
